FIELD OVERSIGHT SUMMARY REPORT  
ACS NPL SITE  
GRIFFITH, INDIANA

JUNE 7, 1999 - JUNE 15, 1999

## USEPA/ARCS V BVSPC Oversight Summary

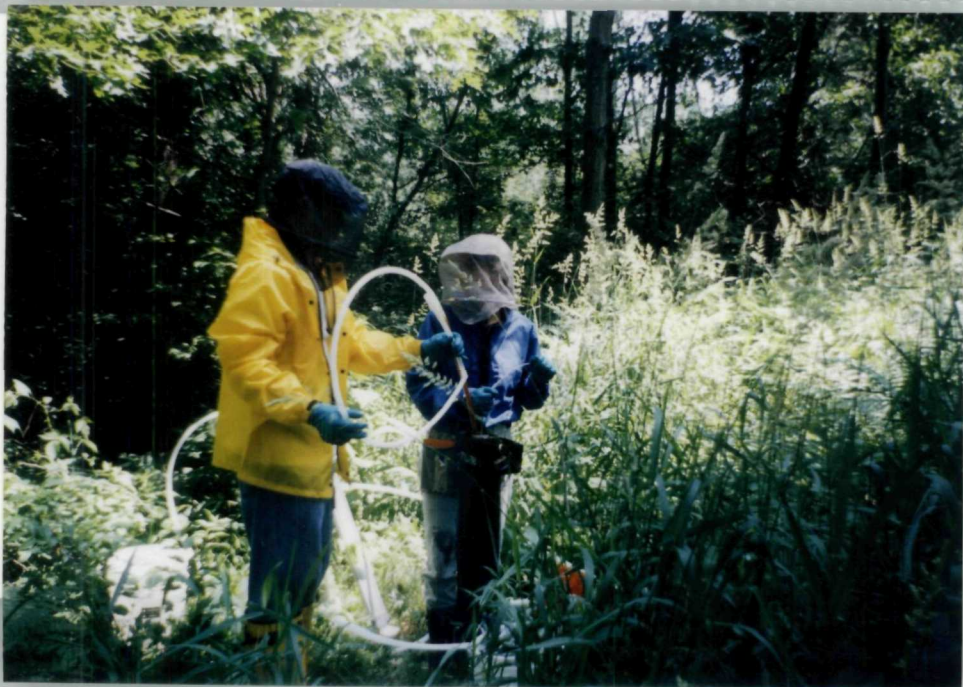
Site: American Chemical Services, Inc.  
 Proj. #: 46517/46518  
 Roll: 1 Photo #:2  
 Date: 06-09-99 Time: 11:40  
 Photographer: Chad Gailey  
 Description: Photo facing northwest at MW-39  
 of Scott Sherman and Judith  
 Kinch installing the low flow  
 pump at MW-39

11:40 Picture #2 of Scott + Judith installing  
the pump @ MW-39 FACING NORTH  
WEST.

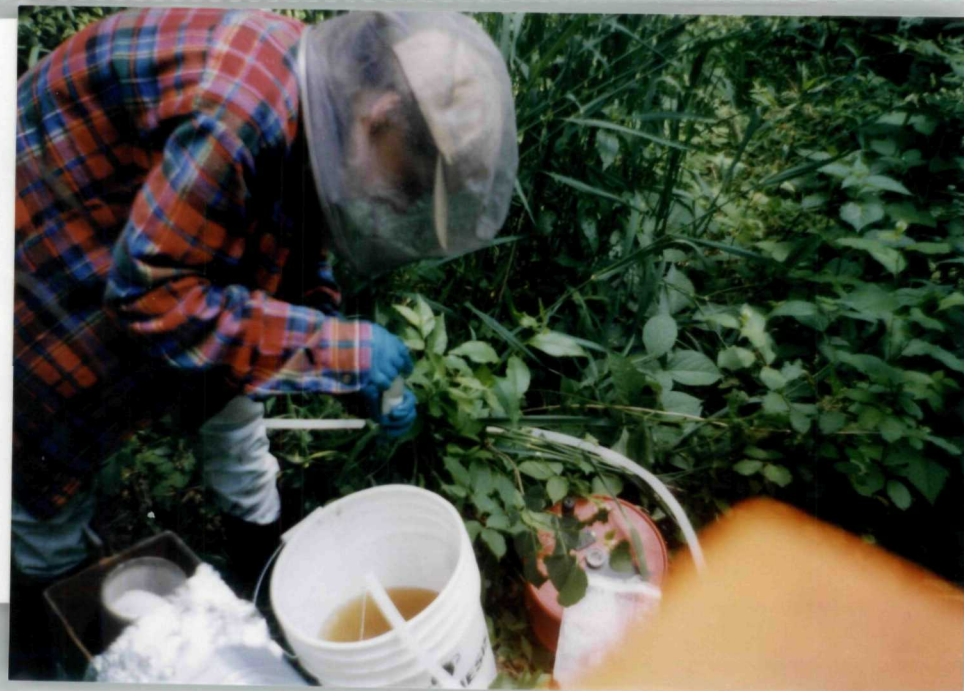
Site: American Chemical Services, Inc.  
 Proj. #: 46517/46518  
 Roll: 1 Photo #:3  
 Date: 06-09-99 Time: 12.25  
 Photographer: Chad Gailey  
 Description: Photo facing northwest at MW-39  
 of Judith Kinch filling a 40ml  
 VOA bottle.

12:25 Picture #3 of Judith Lilling  
AVOA HOTEL @ MW-39, FACING  
NORTHWEST, THIS IS A BIOLOGICAL WELL.

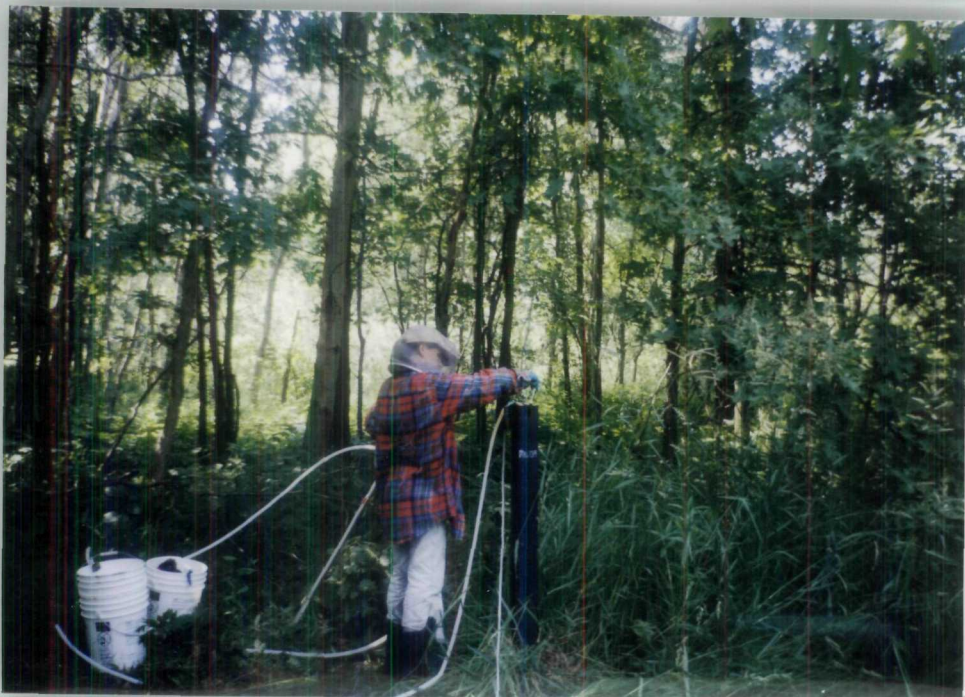
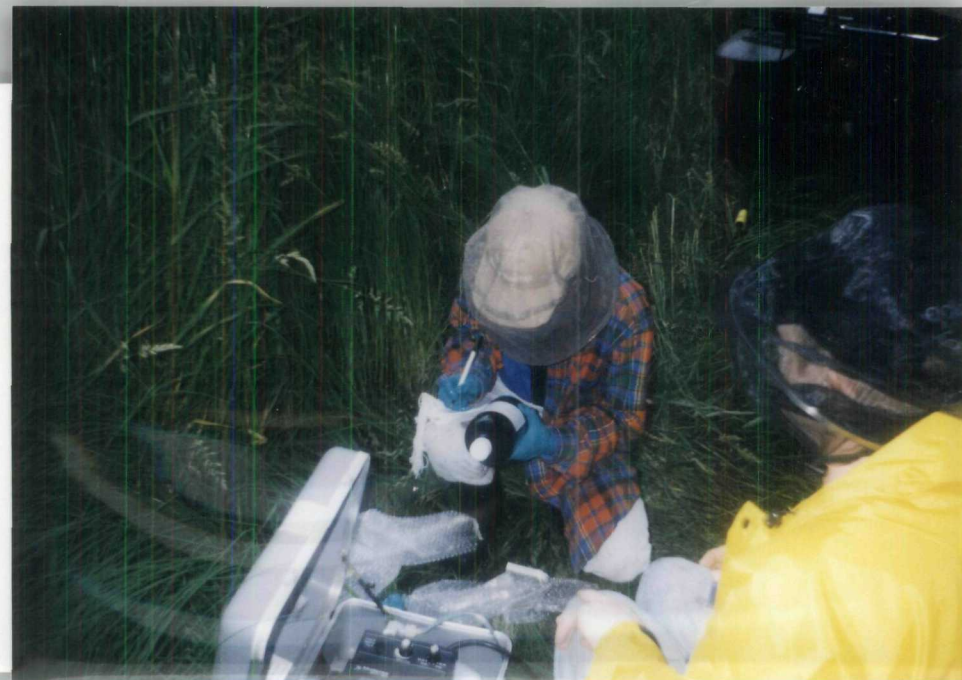
Description: Photo facing northwest at MW-39 of Judith Kinch filling out labels for sample bottles.

15:40 Picture #5 of Scott & Judith  
filling out Labels @ MW-39 FACING  
Northwest, This Bio well.

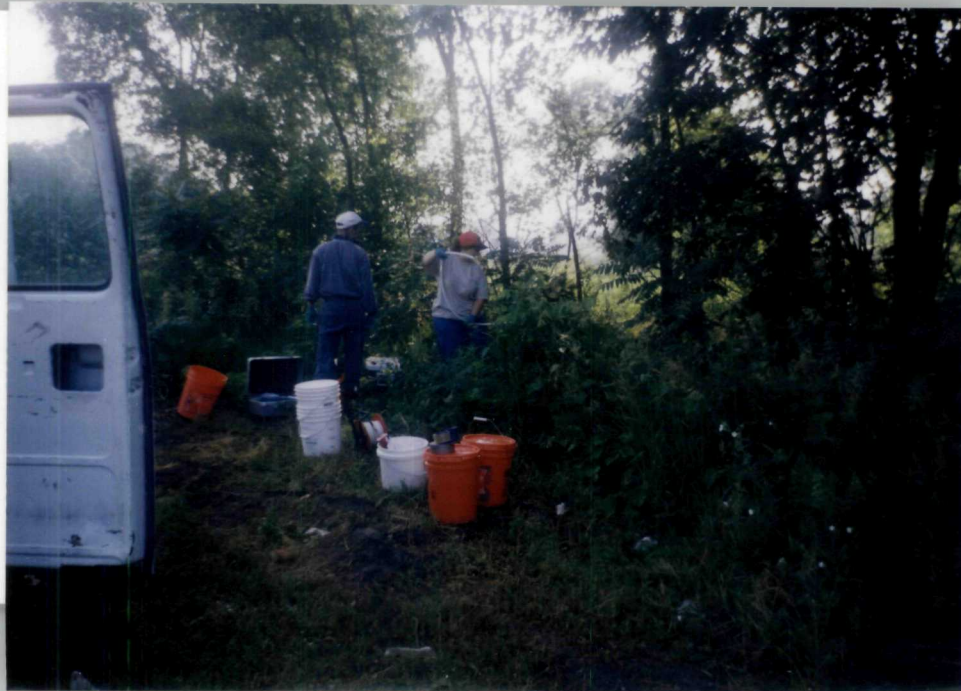
Description: Photo facing northeast at MW-50 of Jennifer Smith and Satjad Ansari installing the low flow pump in MW-50.

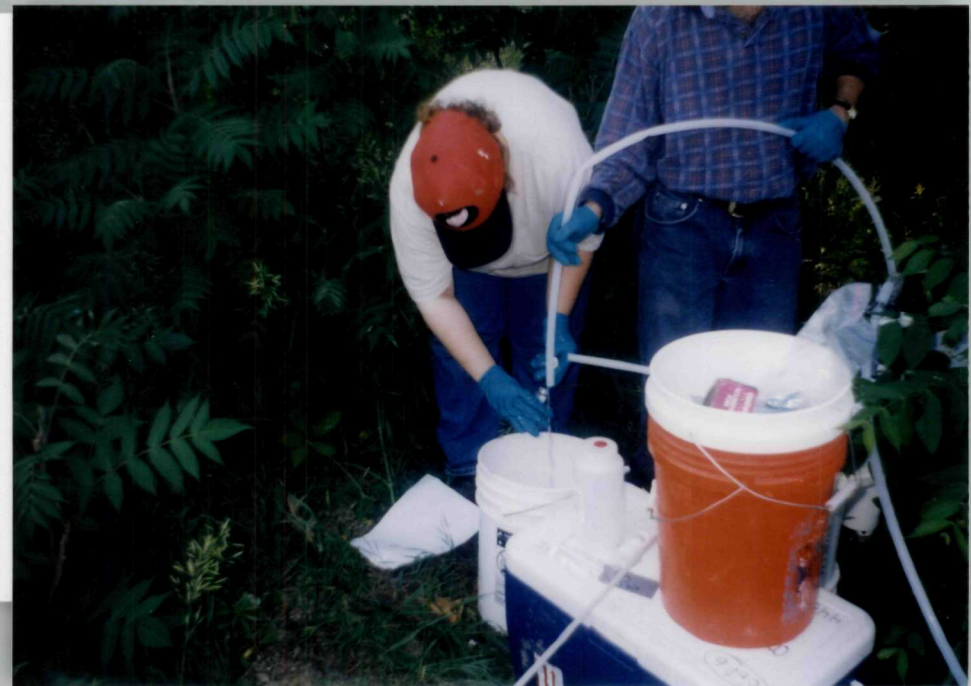
Description: Photo facing northeast at MW-50 of Jennifer Smith filling a VOA bottle at MW-50.

- 09:30 START Sampling.
- 09:35 Picture #7 of Jennifer filling VOA Bottle @ MW-50. Facing Northeast.
- All SOP's were followed. The only problem was the kinks in the Top of the Deadhead Tubings.

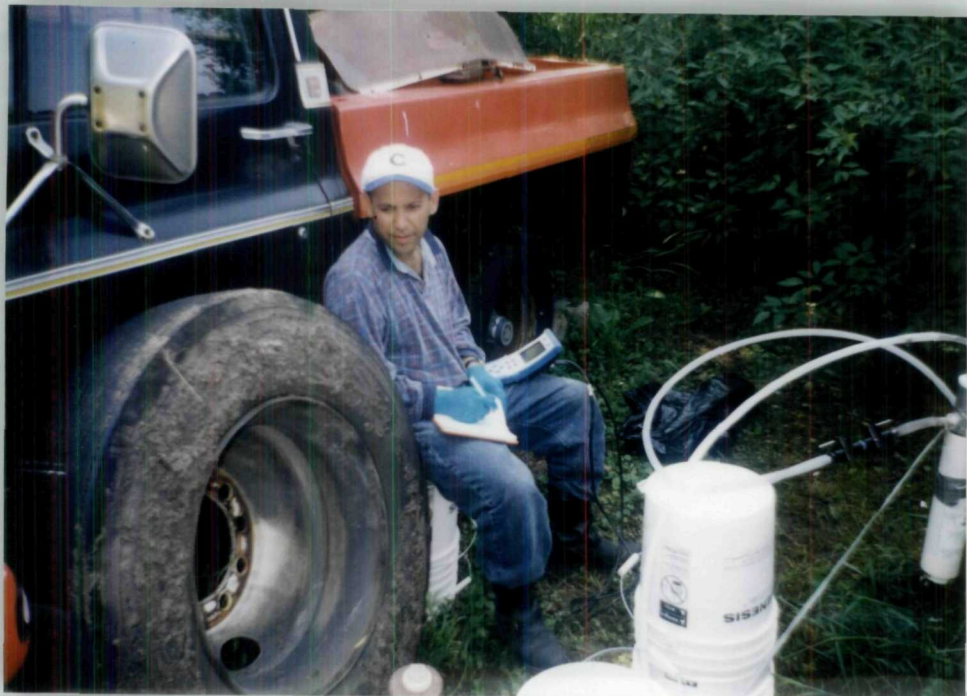
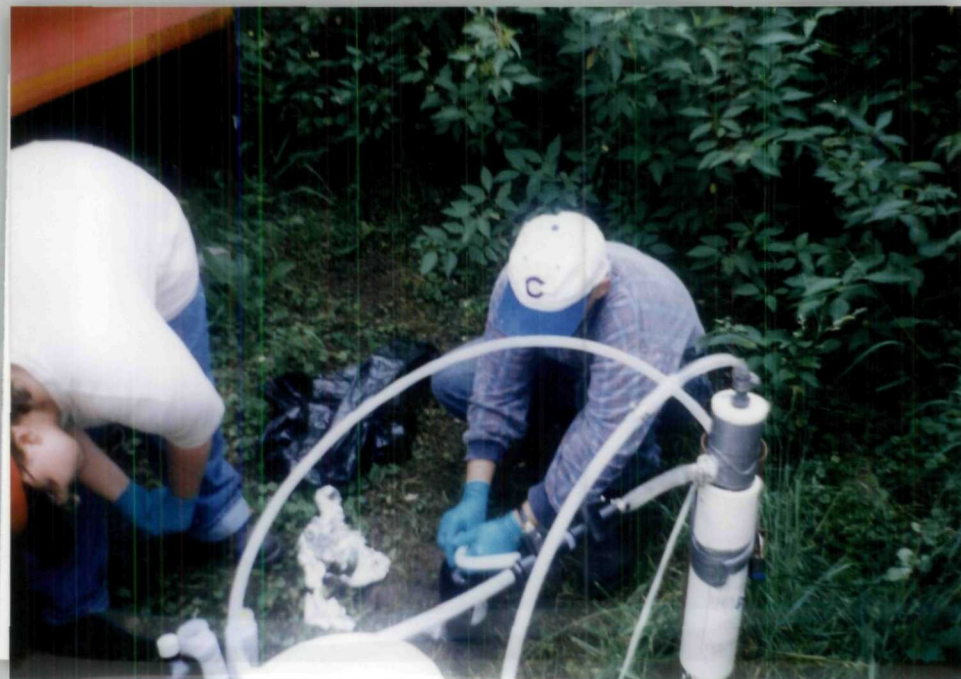
Description: Photo facing southwest at MW-19 of Satjad Ansari filling an amber bottle for PAH's/Phenols.

11:22 Picture #9 of Satjad Filling an  
 Amber Bottle @ mwo19. Facing South  
 west.

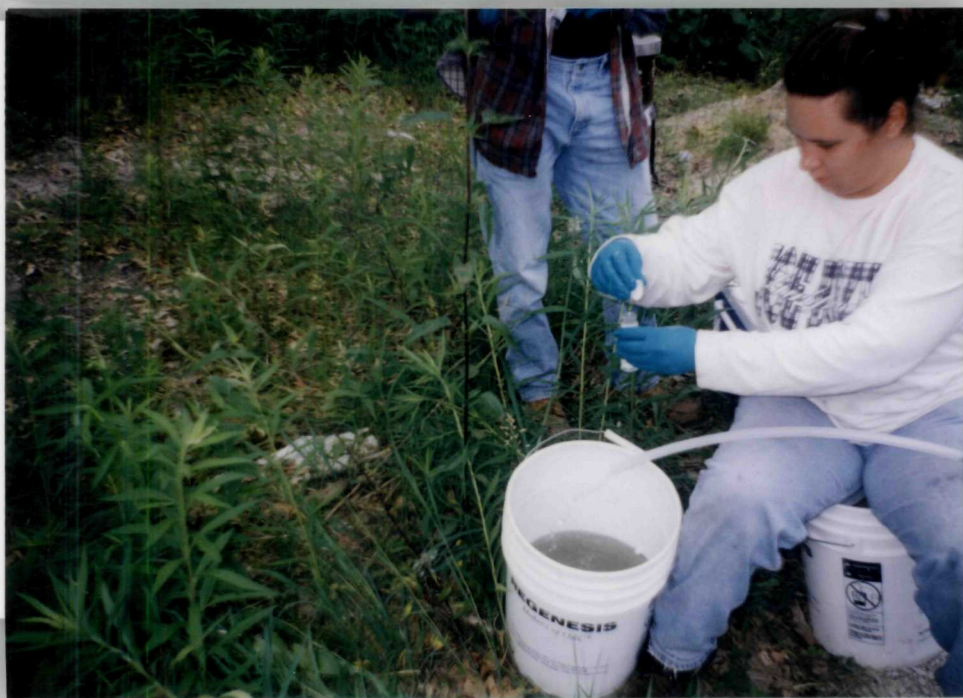
Description: Photo facing east at MW-54 of  
Dawn Daugher and Rob Adams  
filling VOA bottles.

15:20 Picture #10 of Dawn filling a VOA  
 bottle @ mwo54 facing EAST.

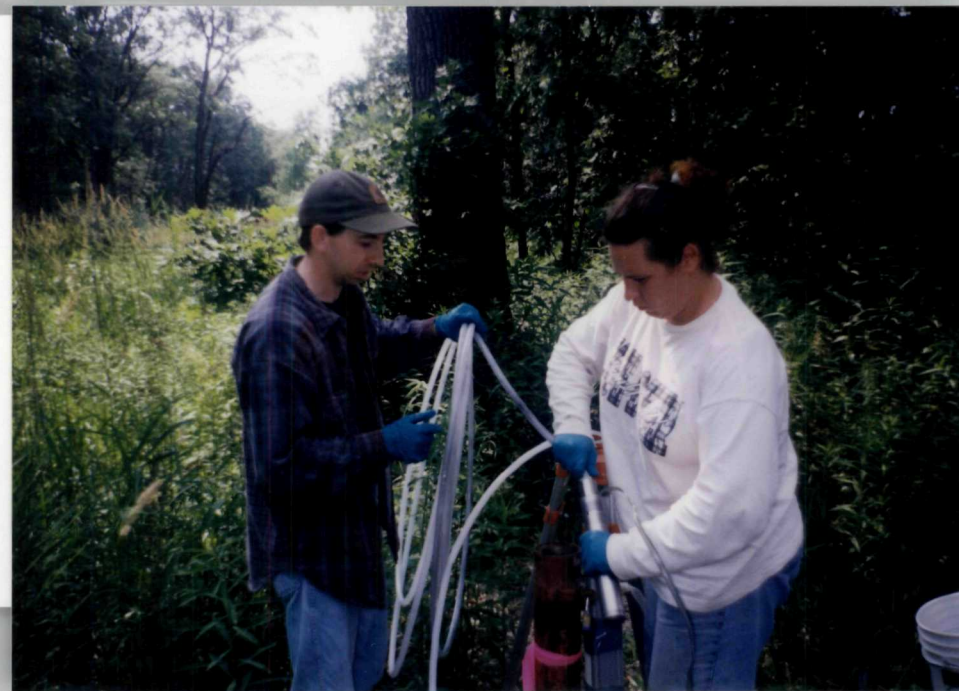
Description: Photo facing east at MW-54 of  
Dawn Daugher and Rob Adams  
pulling the low flow pump out of  
MW-54.

15:30 Picture #11 of Dawn Rob Pulling the  
 Pump out of mwo54.

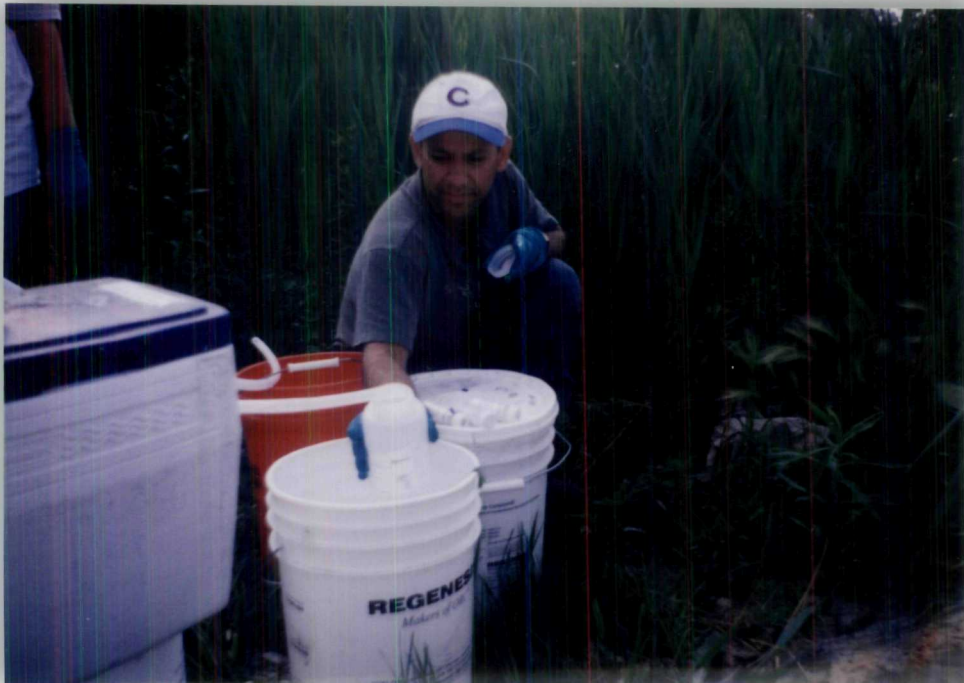
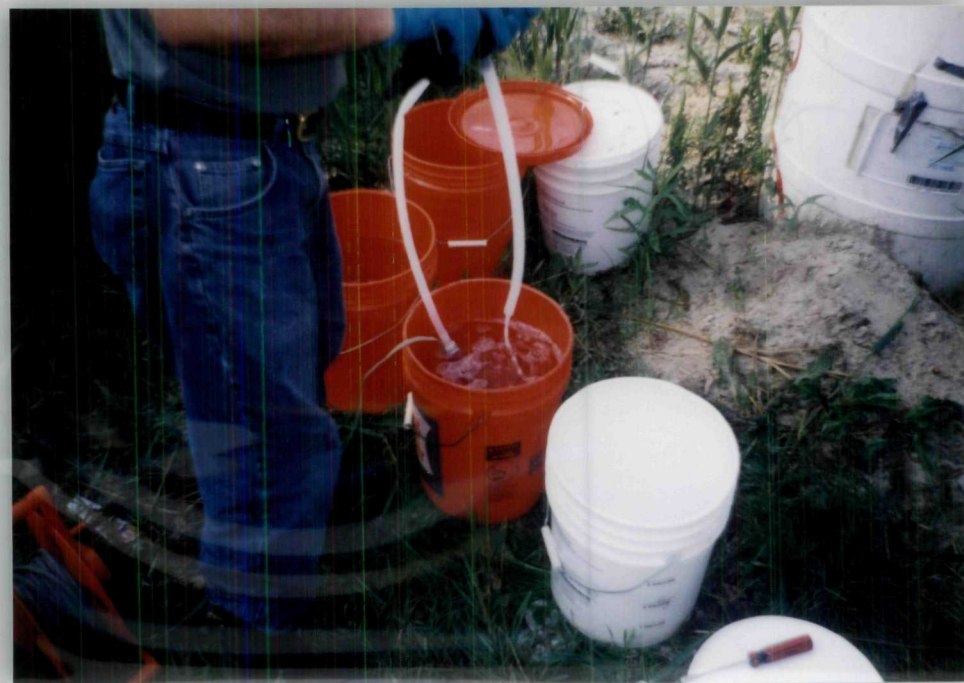
Site: American Chemical Services, Inc.  
 Proj. #: 46517/46518  
 Roll: 1 Photo #: 12  
 Date: 06-11-99 Time: 08:55  
 Photographer: Chad Gailey  
 Description: Photo facing south at M4D of  
 Satjad Ansari filling a poly for  
 RCRA metals.

Site: American Chemical Services, Inc.  
 Proj. #: 46517/46518  
 Roll: 1 Photo #: 13  
 Date: 06-11-99 Time: 09:10  
 Photographer: Chad Gailey  
 Description: Photo facing northwest at M4D of  
 Satjad Ansari Deconning the  
 pump and tubing for M4S.

Picture #12 @ M4D of Satjad  
installing a Poly, facing South

Picture #13 of Satjad Decoding the  
pump @ M4D + M4S, facing South west  
Note that is M4S.

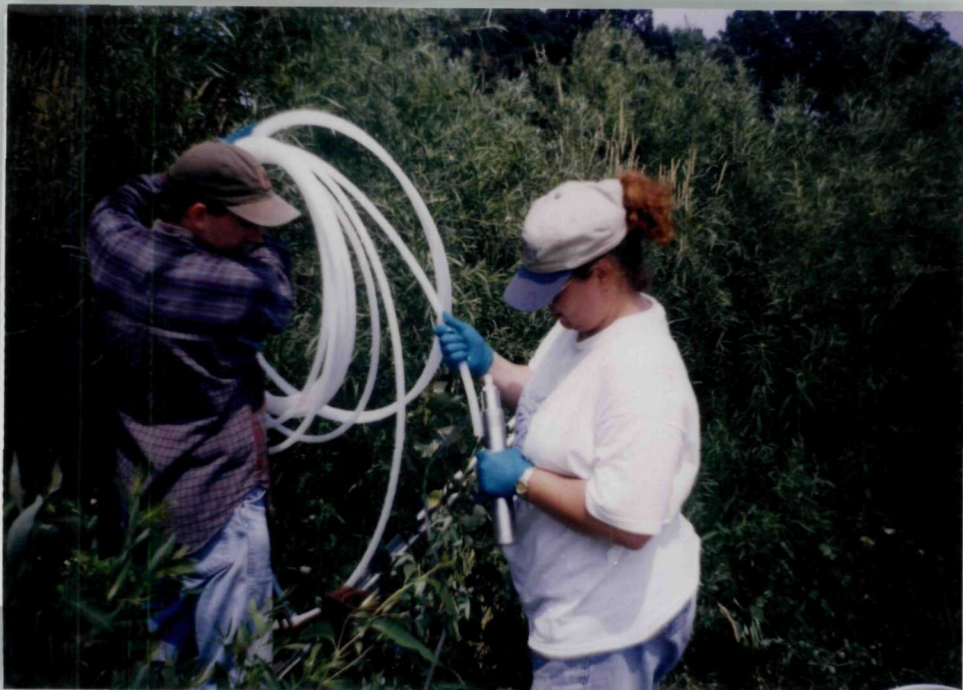
Description: Photo facing north west at MW-33 of Dawn Daugher and Rob Adams installing the pump in MW-33.

Picture #14 of Dawn + Rob Installing  
the pump @ MW-33, facing Northwest

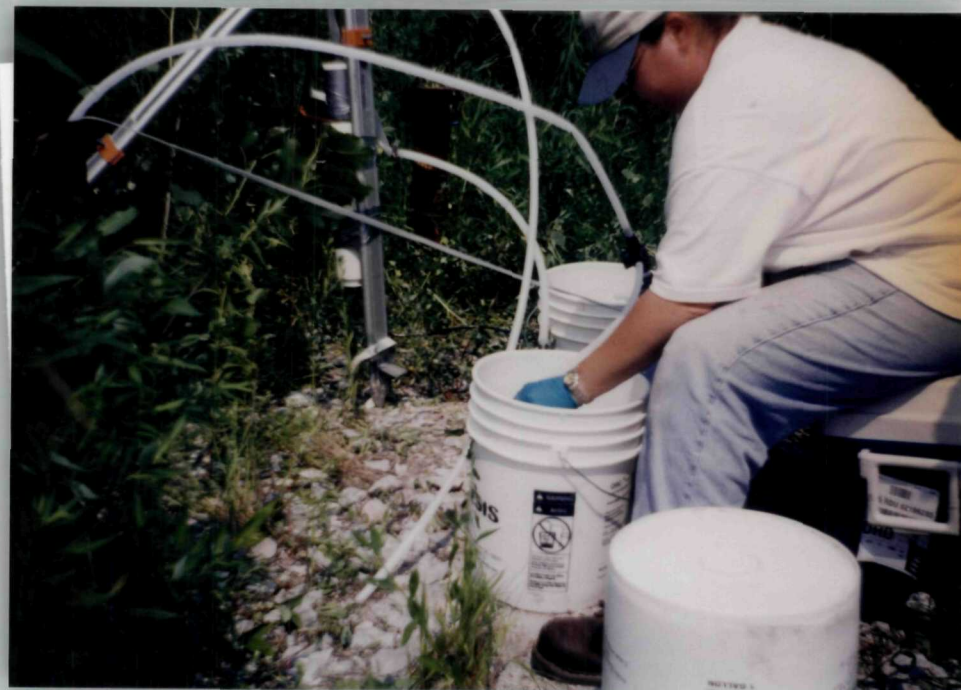
Description: Photo facing northeast at MW-35 of Dawn Daugher filling a 40ml VOA bottle.

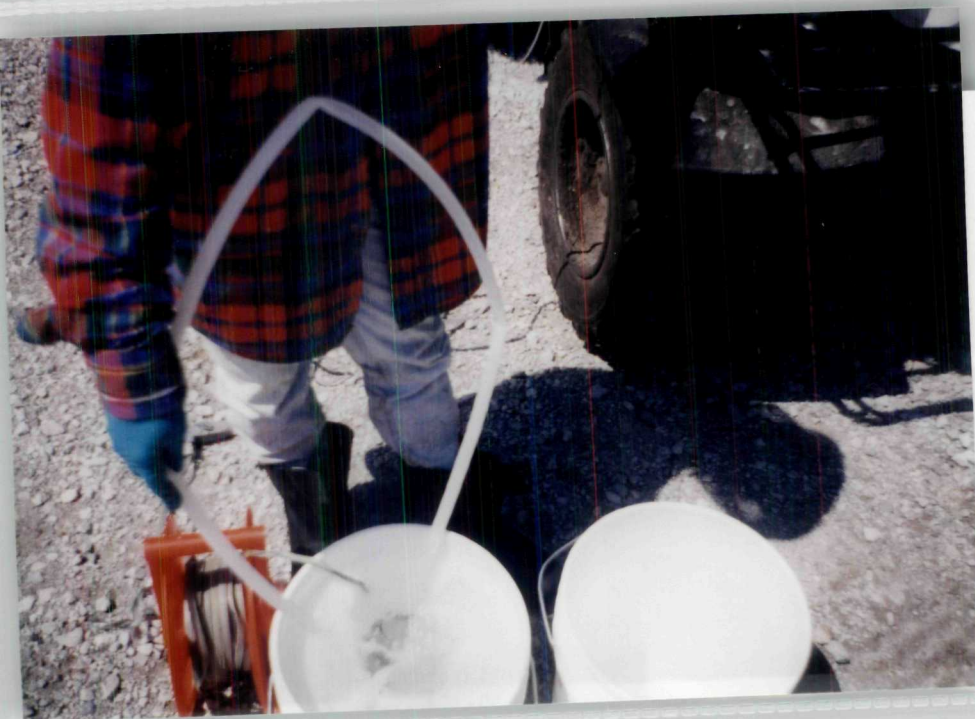
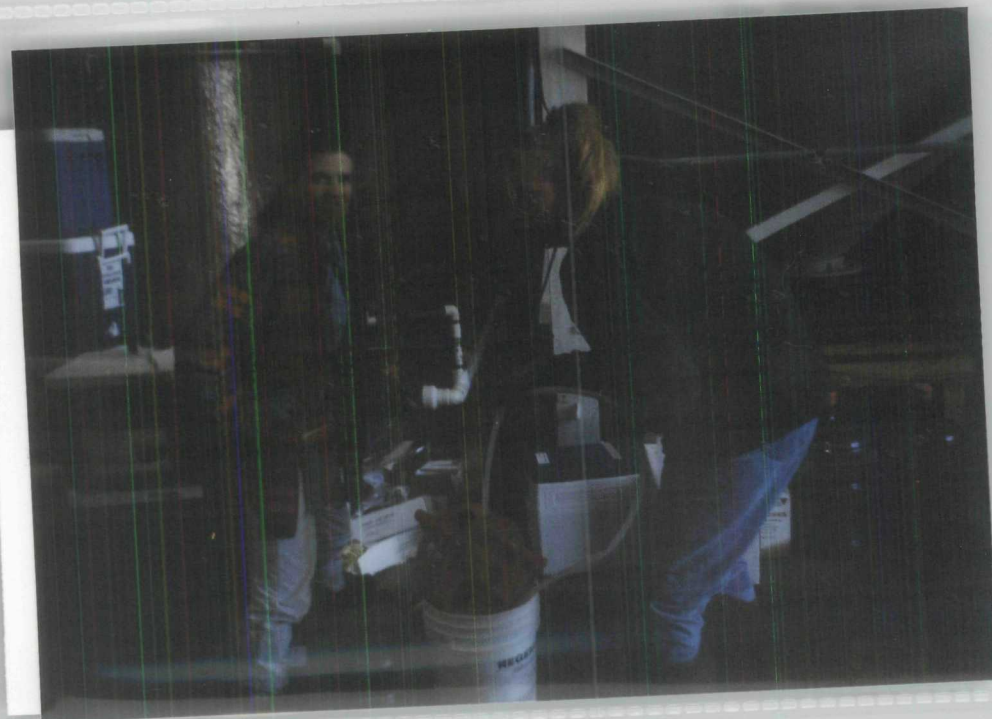
Site: American Chemical Services, Inc.  
 Proj. #: 46517/46518  
 Roll: 1 Photo #:16  
 Date: 06-14-99 Time: 11:15  
 Photographer: Chad Gailey  
 Description: Photo facing southwest of Judith  
 Kinch deconning the low flow  
 pump and tubing in fount of the  
 water treatment building.

Site: American Chemical Services, Inc.  
 Proj. #: 46517/46518  
 Roll: 1 Photo #:17  
 Date: 06-14-99 Time: 14:30  
 Photographer: Chad Gailey  
 Description: Photo facing south inside the  
 water treatment building  
 deconning the low flow pump and  
 tubing for MW-07.

Picture #16 of Judith Decann  
the pump in front of the  
WATER TREATMENT Bld Facing  
South west.

Picture #17 of Judith and Trisha  
Decann the pump + taking picture  
the Water Treatment Bld.

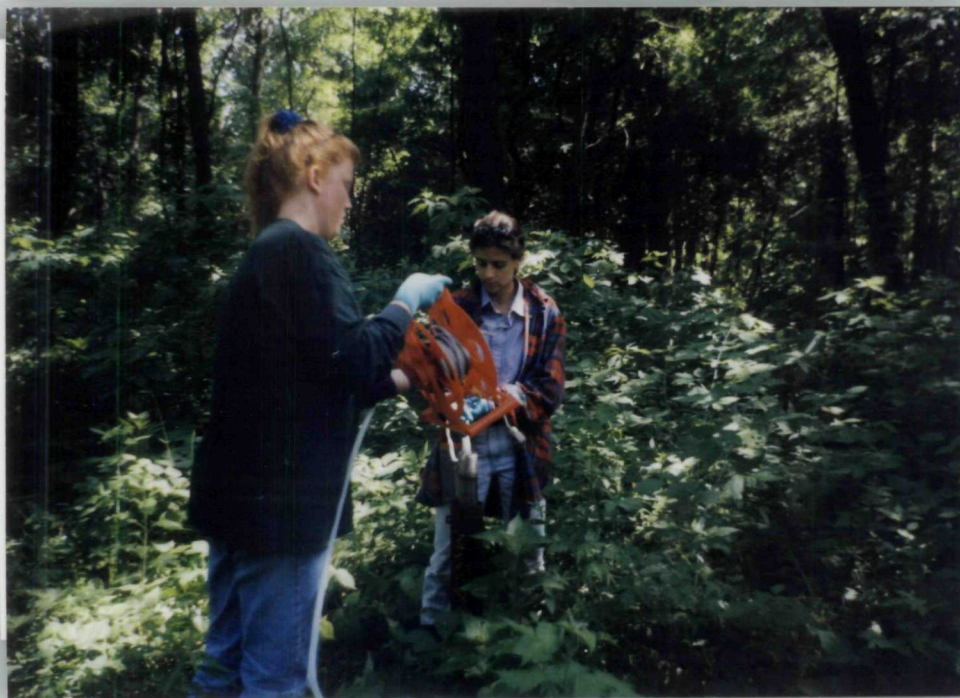
Site: American Chemical Services, Inc.  
 Proj. #: 46517/46518  
 Roll: 1 Photo #:18  
 Date: 06-14-99 Time: 15:50  
 Photographer: Chad Gailey  
 Description: Photo facing south of Judith  
 Kinch and Trisha Woolslayer  
 pulling the low flow pump out of  
 MW-07.

15:50 Trisha + Judith pulling Pump out  
of mwoz.  
Picture # 18 of Trisha +  
Judith

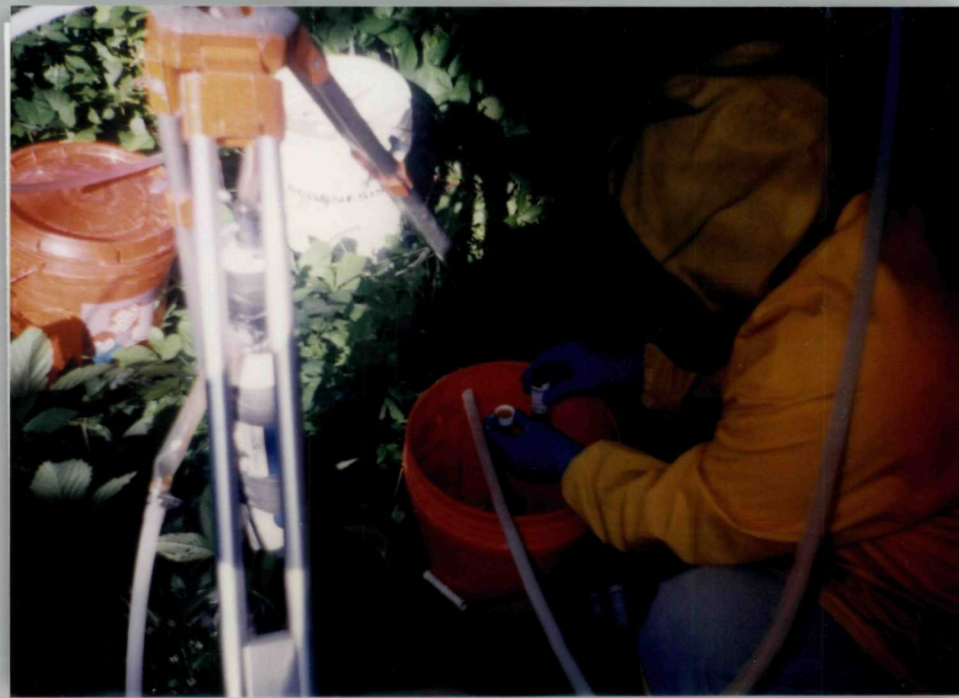
Site: American Chemical Services, Inc.  
 Proj. #: 46517/46518  
 Roll: 1 Photo #:19  
 Date: 06-14-99 Time: 17:25  
 Photographer: Chad Gailey  
 Description: Photo facing northeast of Dawn  
 Daugher filling a VOA bottle.

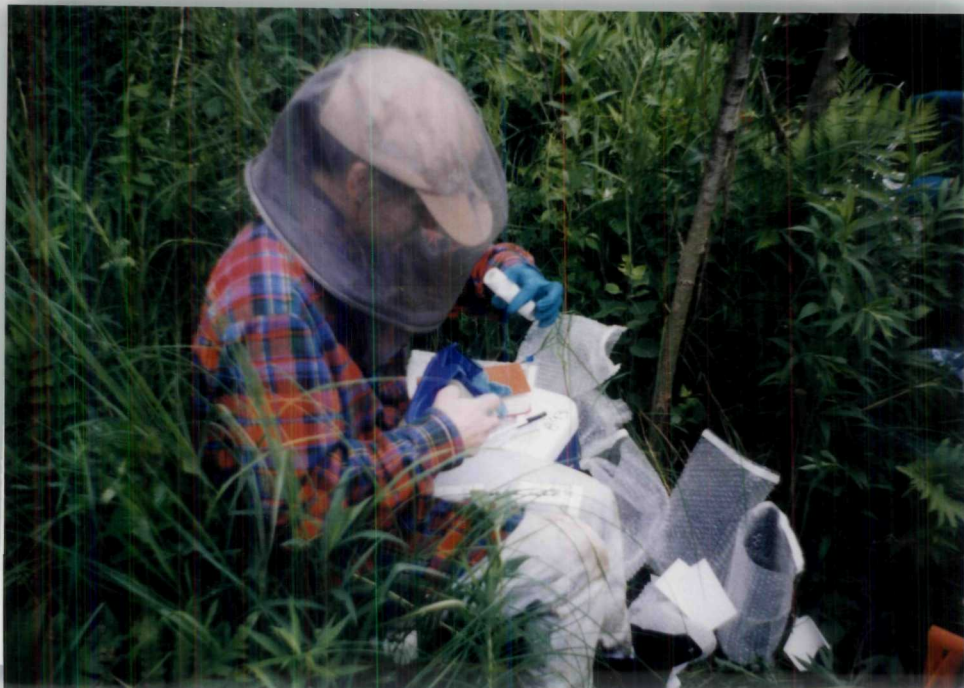
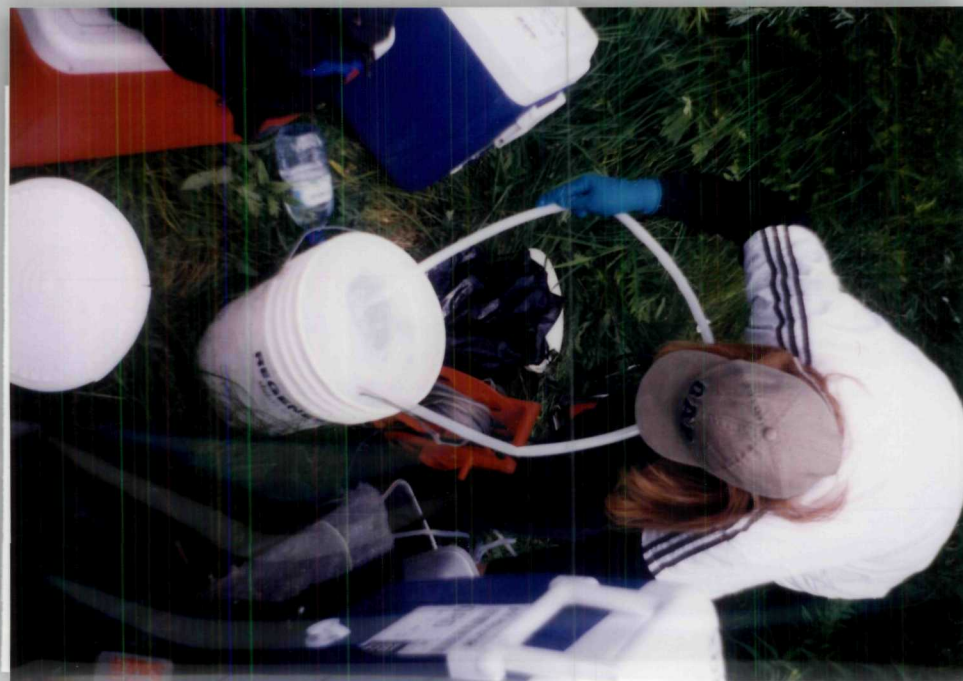
Description: Photo facing north of Trisha  
Woolslayer deconning the low  
flow pump near MW-53 for MW-  
52.

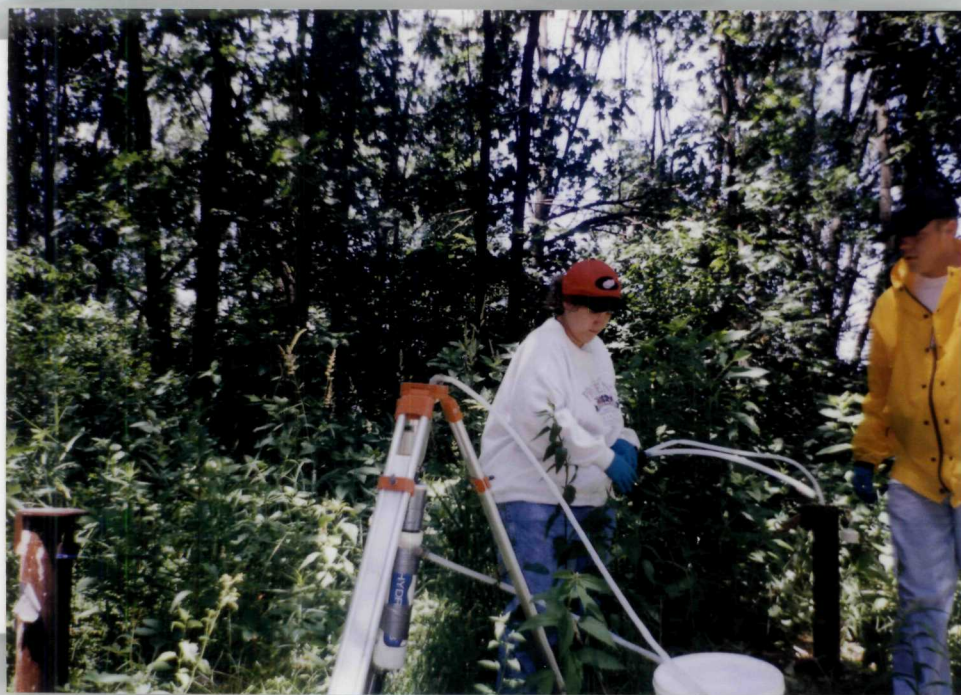
Site: American Chemical Services, Inc.  
 Proj. #: 46517/46518  
 Roll: 1 Photo #:22  
 Date: 06-15-99 Time: 13.05  
 Photographer: Chad Gailey  
 Description: Photo facing northwest at MW-29  
 of Jennifer Smith hooking up the  
 Hydrolab to take water quality  
 parameters.

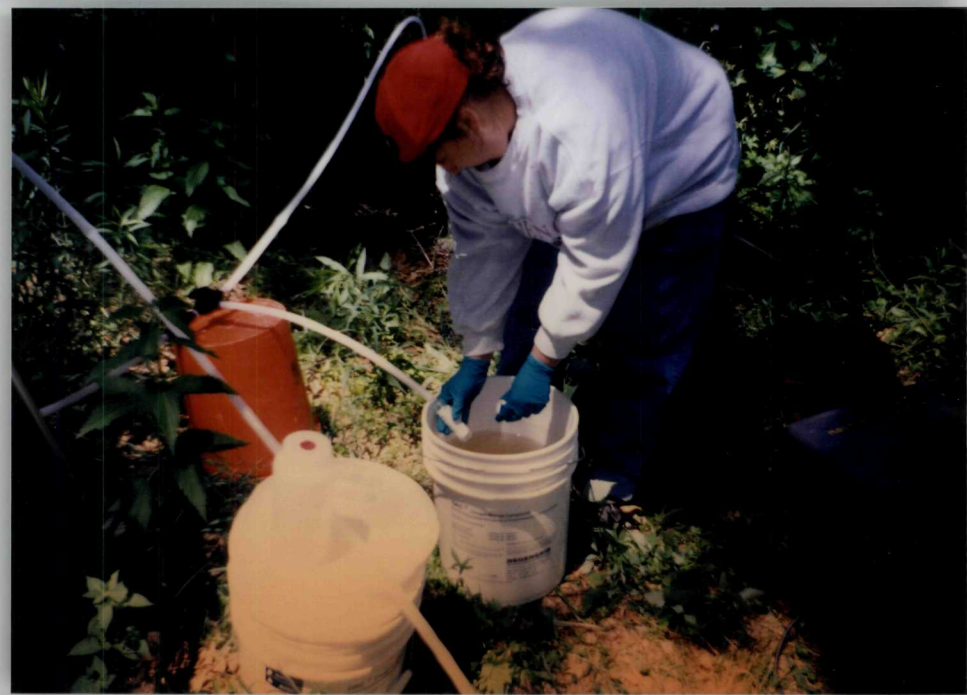
Site: American Chemical Services, Inc.  
 Proj. #: 46517/46518  
 Roll: 1 Photo #:23  
 Date: 06-15-99 Time: 14:07  
 Photographer: Chad Gailey  
 Description: Photo facing northwest at MW-29  
 of Jennifer Smith filling a VOA  
 bottle.

- 13:09 Depth to water @ MW-29 15.00 ft  
 13:15 Depth to water @ MW-29 15.00 ft  
 No Observed Draw Down.  
 13:20 Depth to water @ MW-29 15.00 ft  
 14:02 Start Sampling @ MW-29  
 Last 3 parameters ARE within  
 10%  
 14:07 Picture #23 of Jennifer Silling  
 & VOA @ MW-29, facing  
 North west  
 14:36 Finish Sampling, mob to MW9R  
 AND Decoding Pump Jennifer & Scott.  
 14:40 Setting up on MW9R  
 14:43 Start Pumping MW9R  
 14:48 Depth to water 16.24 ft  
 15:15 Depth to water 16.24 ft  
 No observed Draw Down.  
 15:30 START Sampling MW9R this is  
 MS/MSD  
 15:35 Picture #24 of Jennifer & Scott  
 Silling, VOA @ MW9R, facing  
 North west  
 16:10 Trisha & Judith setting up on MAWOC  
 Scott & Jennifer ARE Picking Samples

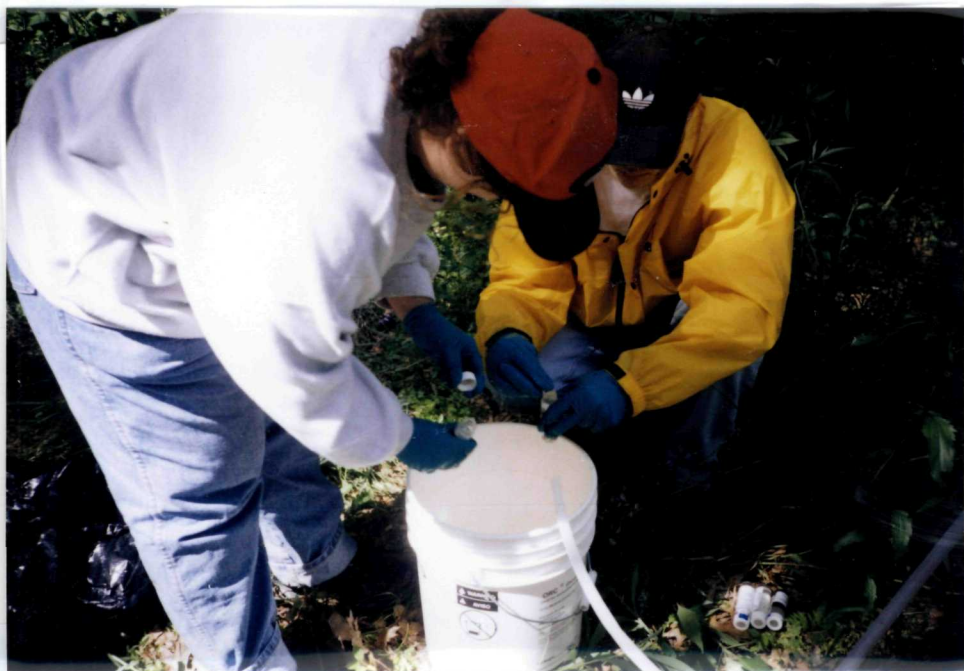
Site: American Chemical Services, Inc.  
Proj. #: 46517/46518  
Roll: 1 Photo #:24  
Date: 06-15-99 Time: 15:35  
Photographer: Chad Gailey  
Description: Photo facing northeast at MW9R  
of Jennifer Smith and Scott  
Sherman filling VOAs.
